Manhole Inspection Summary

Manhole # S19E__046MH

Insp Date: **8/10/09 10:44 AM**

Location Address: **325 N PAYSON ST**

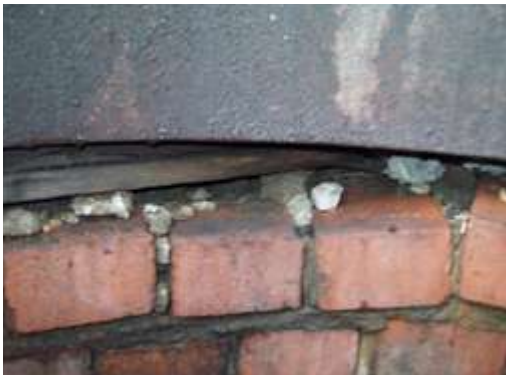
Defect 1

Condition: ☐ Sound ☐ Cracked ☐ Root Intrusion ☒ **Loose Brick** ☐ Deteriorated

LOOSE AND MISSING BRICKS

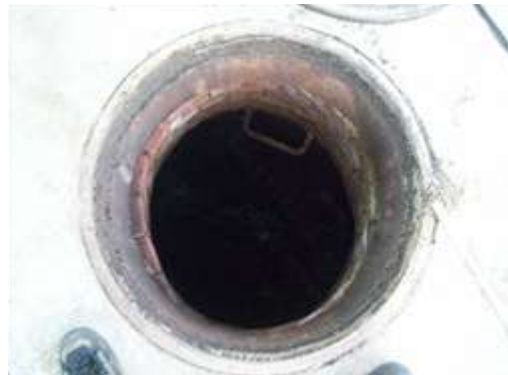
Defect 3

Frame Offset: **1** (in.) Condition: ☒ Sound ☐ Cracked ☐ Leaks

frame offset

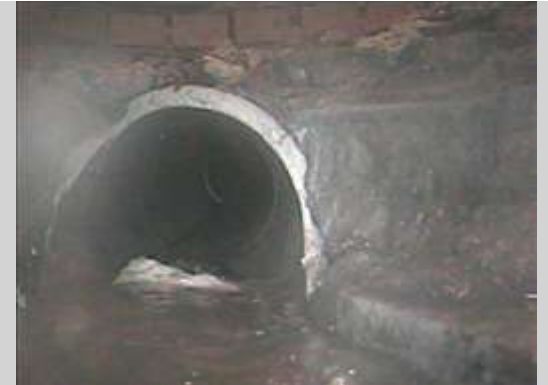
12 O'Clock Outflow

10 in. Circular Gravity Sewer
Pipe Out @ 12 O'Clock

Pipe Height: (in.) Direct
Pipe Material: **Clay** ☐ Pipe Lined
Invert Depth: **7.44** (ft.) Flow Characteristics: **Slow**
Deposits: ☒ None ☐ Mud ☐ Sludge ☐ Debris ☐ Grease
Silt Depth: (in.) Deposits Extent:
Infiltration: **None** Pipe Seal Cond: **Sound**

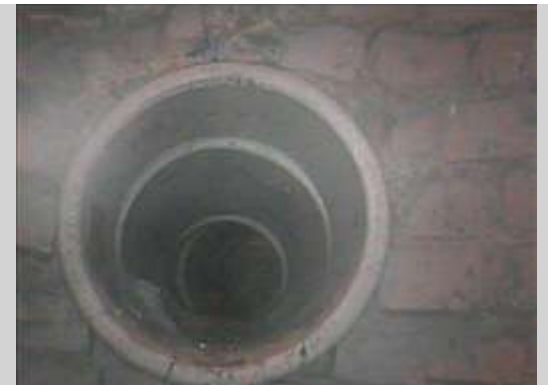
5 O'Clock Inflow

10 in. Circular Gravity Sewer
Pipe In @ 5 O'Clock

Pipe Height: (in.) Direct
Pipe Material: **Clay** ☐ Pipe Lined
Invert Depth: **5.30** (ft.) Flow Characteristics: **Slow**
Deposits: ☒ None ☐ Mud ☐ Sludge ☐ Debris ☐ Grease
Silt Depth: (in.) Deposits Extent:
Infiltration: **None** Pipe Seal Cond: **Sound**

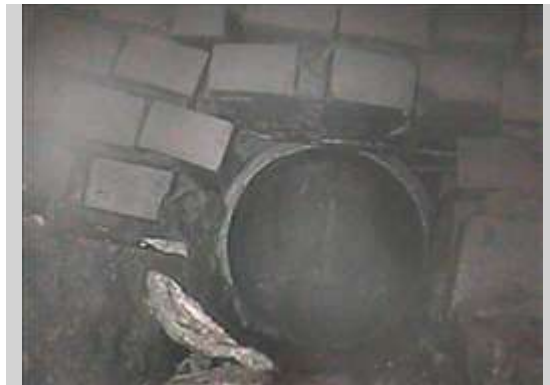
Drop In @ 5 O'Clock

Drop: **Outside Direct**
Angled: Reading: (ft.)
Inv Depth: **7.45** (ft.)
Drop Condition: **Open**

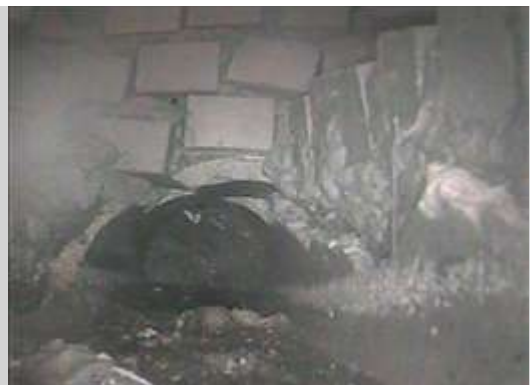
6 O'Clock Inflow

10 in. Circular Gravity Sewer
Pipe In @ 6 O'Clock

Infiltration: **None** Pipe Seal Cond: **Sound**
